Water System Improvement Project

Los Toros, Dominican Republic

Assessment Report – Phase 1

Marquette University Engineers Without Borders Chapter

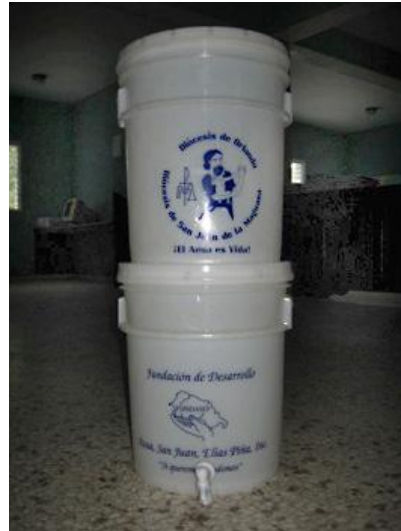
Figure 1-01: String-Carbon Filter

The water filters consist of two buckets joined by a PVC casing which holds the carbon filter and string element (see Figure 2.1 at right). Water is placed in the upper bucket and 25 drops of chlorine are added to the full bucket in order to disinfect the water. After the water has passed through the filters, it is collected in the lower bucket and a plastic valve allows the user to fill other containers with the water once it is treated. The string element is intended to remove particulates before passing through the carbon filter, which is intended to remove some of the residual chlorine and harmful organic compounds in the water.

Physical filtration by means of the string filter may still be a beneficial step in the process in that it can help to remove larger matter and particulates that may be in the water. However, over time the filter may actually cause more harm than benefits if bacteria begin to be retained in the filter and thrive in the moist, hot environment. For this reason, changing filter elements at the manufacturer’s recommended interval (8-12 months) is an important maintenance requirement that should not be ignored.

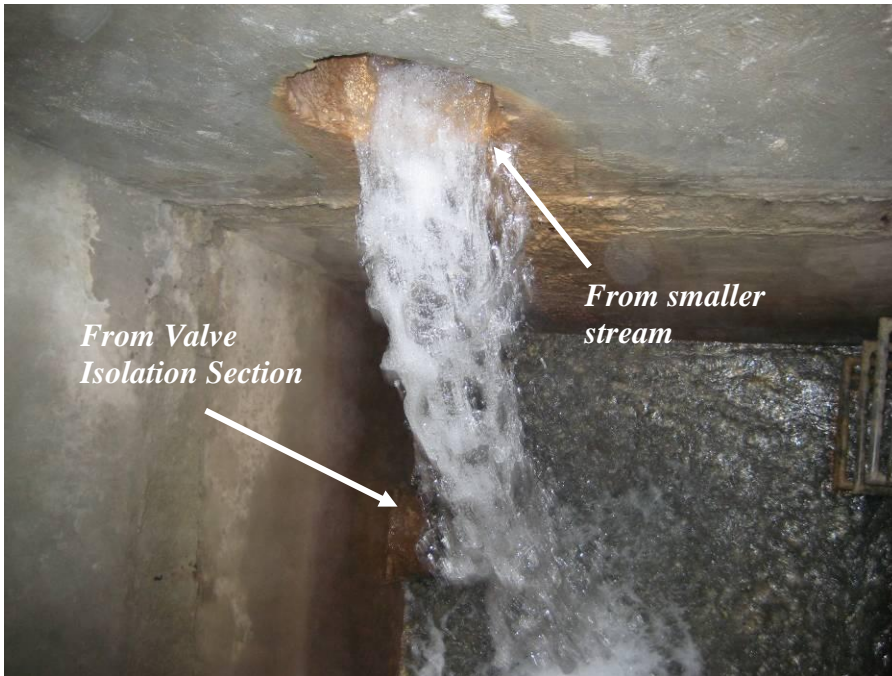
Figure 3-02: Collection Tank

In the caption tank, there are three separate sections. The first is the actual collection tank, where water moves swiftly (see photo)

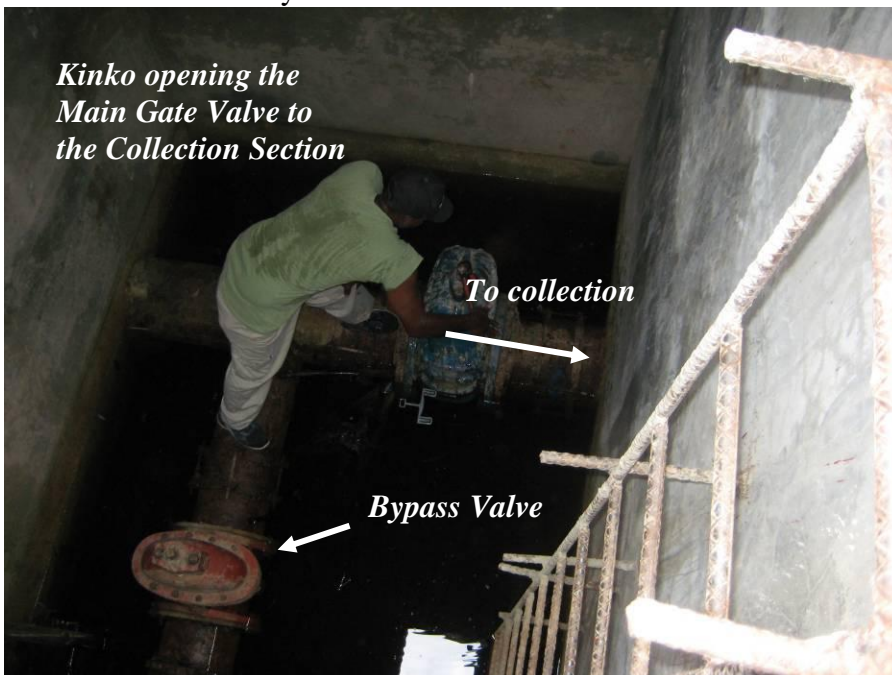
Figure 3-03: Valve Access Tank

The second section, which is closer to the dry river sand filter bed, contains the pipe from sand filter to the first collection tank. There is also a bypass pipe which conveys water directly from the sand filter to the main aqueduct line. Both pipes are 16” and have manual gate valves to actuate the individual lines. Kinko keeps the valves closed during normal operating conditions in order to maintain moisture in the sand filter. According to Kinko, letting the sand filter go dry will damage it in the future. Therefore, whenever it rains, Kinko travels up the dry river bed and opens the valve manually to allow sufficient flow to the community.

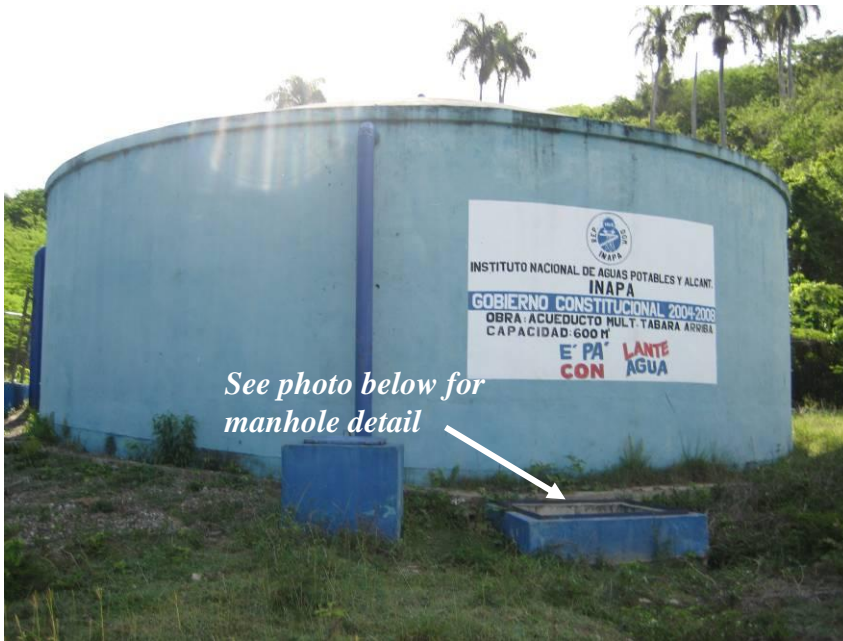
Figure 3-05: Sahanoa-Tabbara Storage Tank

The secondary tank is in good physical condition, with no visible signs of leakage from the concrete structure.

Related to infrastructure, the villages of Sahanoa and Tabara Arriba benefit from having a fairly large cast water tank, which helps to provide more consistent water flows to their system. In the case of Los Toros, the water is essentially conveyed directly from its source to the town, with no intermediate storage device. To this end, employing some

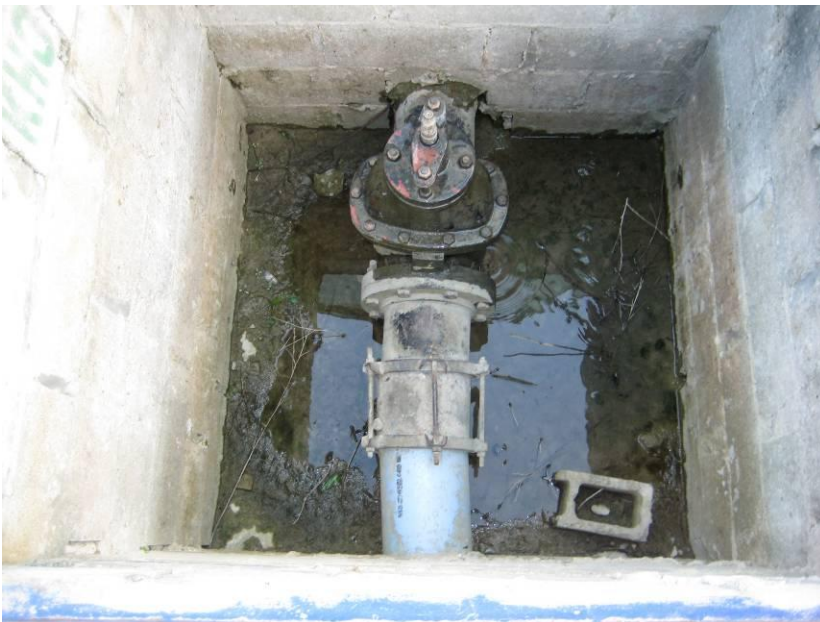
Figure 3-06: Sahanoa-Tabbara Storage Tank Outlet Valve

According to Kinko, all of the piping from the Caption tank to the secondary tank is Ductile Iron. The piping from this tank to the towns of Tabara Arriba and Sahanoa appear to be PVC (see photo below). Using a diameter tape, this pipe measures 8”.

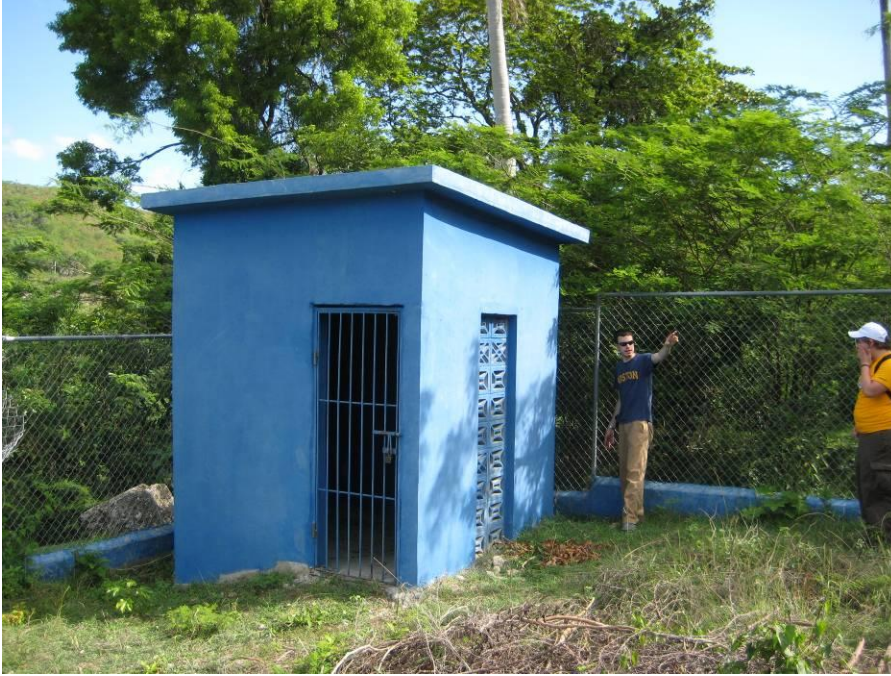
Figure 3-07: Chlorine Caseta #1 (out of service)

The water for usage in Los Toros is conveyed via the other branch of this aqueduct junction. There is a caseta (maintenance shack) in which you can access the aqueduct leading to Los Toros (see photo below).

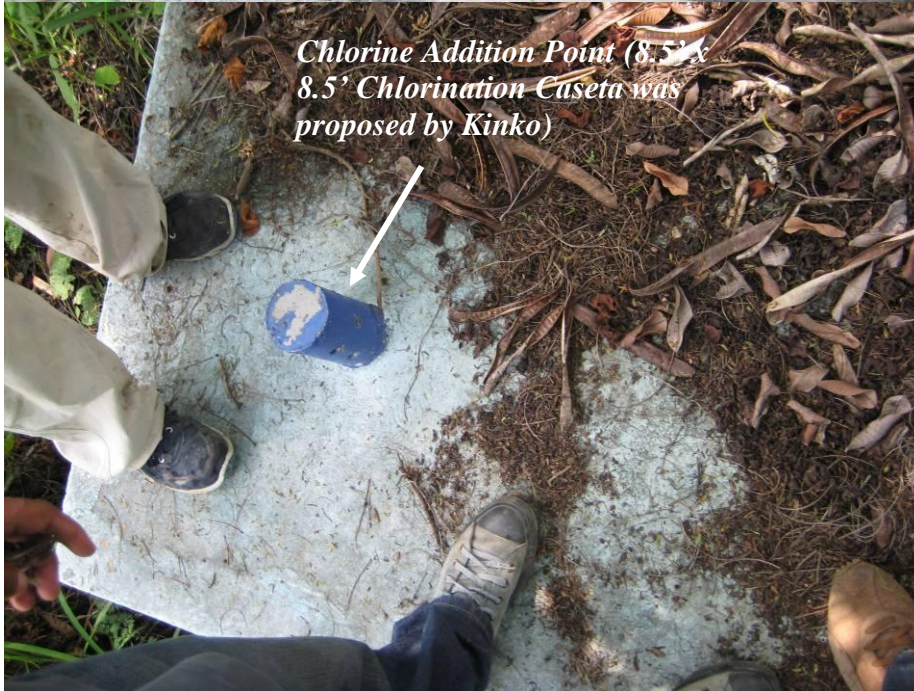
Figure 3-08: Chlorine Contact Tank (out of service)

The next major junction is at the chlorination tank to Los Toros. This tank solely serves Los Toros. The chlorination tank has not been in service for approximately 10 years. There is a 6" inlet with a manual valve to the tank. The aqueduct water mixes with a chlorine solution and flows from the tank via two 6" outlet pipes. The 2 outlet pipes were installed for redundancy, and they join together shortly after the chlorination tank via a Y-intersection. In theory, as explained by Kinko, a solid chlorine compound is added to the tank via a small box. The box introduces water to the compound and chlorine solution is added to the main tank via a small pipe by a drip mechanism. Depending on water flow through the system, he would add between 1-2 pounds of chlorine to the tank. Maintenance consisted of monthly cleaning of sediment with brushes, and flushing to the local fields. The chlorination tank is currently being bypassed. The estimated size of the chlorination tank is 25,000 gallons.

*Inlet Pipe to
Chlorination Tank*

*Chlorine Addition Point (8.5' x
8.5' Chlorination Cuseta was
proposed by Kinko)*

form of storage could help to provide more consistent flow of water to the village. Although the chlorine tank is not currently used for treatment, it could serve useful as a storage device to help dampen out the surges in water flow and store the excess water during dry periods. If this does not produce the desired results, investigating the cost and feasibility of water tower in the town could be a further investigation.

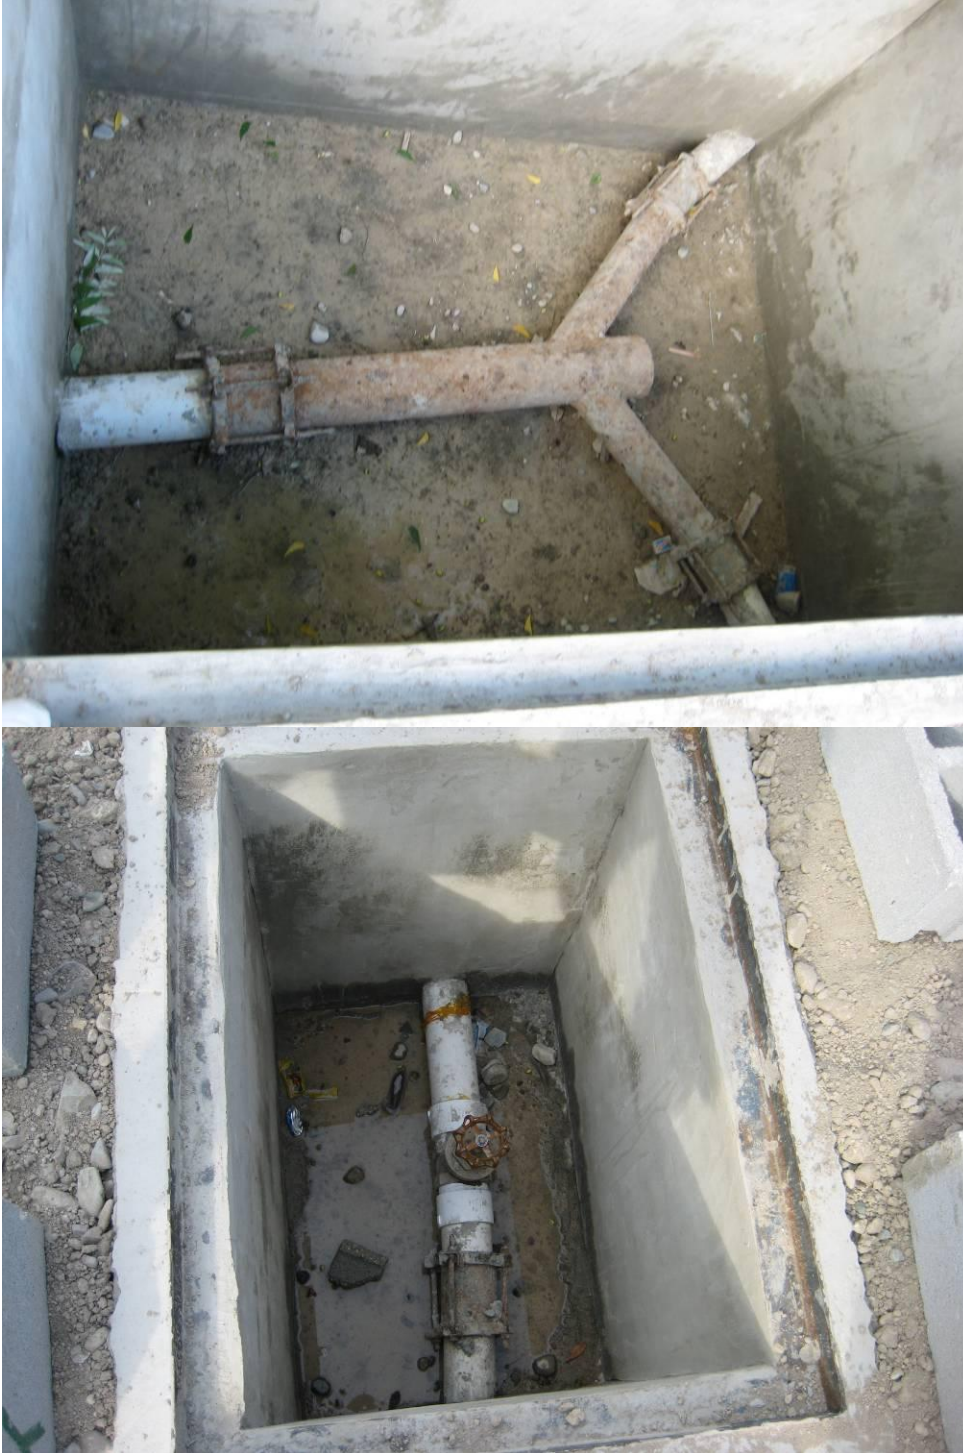
Figure 3-10: Distribution System Manholes

Kinko has also been building “registros” or manholes around the village in order to isolate off the system for maintenance. Two of the three manholes that he has built are displayed below:

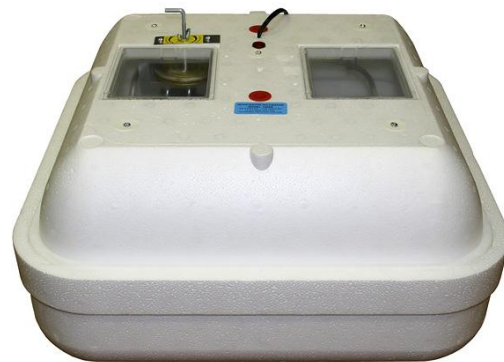
Figure 4-01: Hovabator Incubator

the mixture solidifies after approximately 1 hour. The Petri dishes were placed in a Hovabator® Incubator at between 35 and 40 degrees C for a 24-hour period of time and examined to quantify coliforms, fecal coliforms (e. coli presence), and bacteria in the solidified medium. There were some periods where the power went out for a long enough time to discharge a small uninterruptible power source connected to the incubator, however the temperature stayed above 27 degrees C, therefore the samples were allowed to sit for an additional 6-12 hours. The user can then count the number of contaminants found per sample and compile data about the concentration of these potentially harmful organisms in the water.

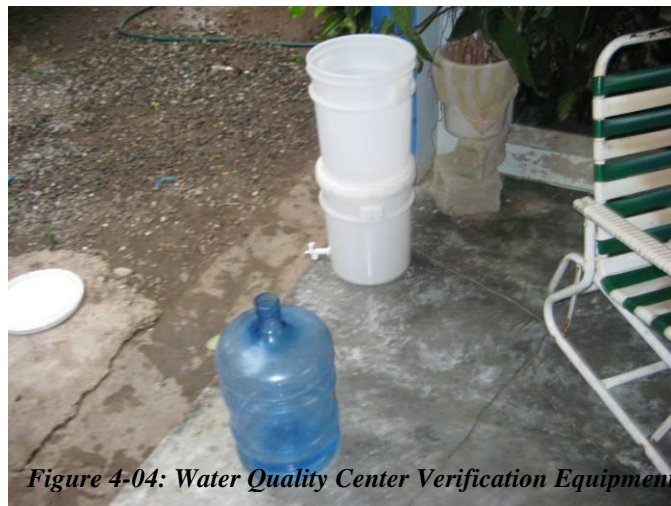
Figure 4-04: Water Quality Center Verification Equipment

The last part of the water testing consisted of using the proposed treatment method which was generated at the Water Quality Center in the field. To that end, a string-carbon filter that had been in use for less than a year was obtained from a local family. The filter element was removed from the PVC casing, and shock chlorinated using the 4 oz chlorine bags (5.65 % Chlorine). The filter element was

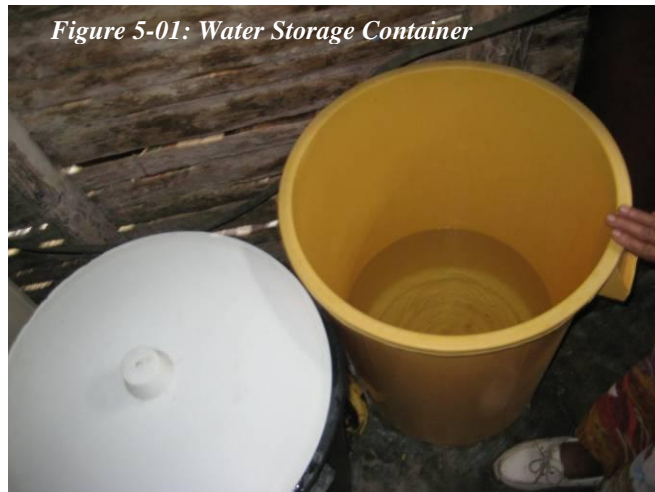
buckets and barrels. A typical storage container is shown at right. One possible problem that arises is a lack of cleaning and maintenance on these containers, as well as the possibility of creating a place for water-borne bacteria to thrive. Beyond drinking

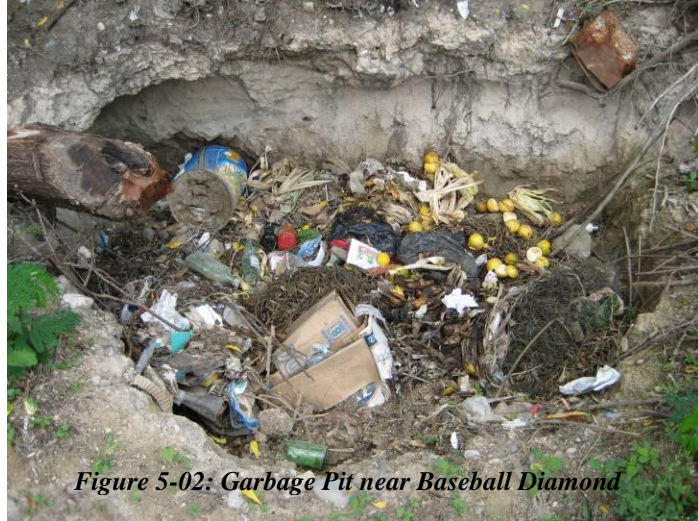
Figure 5-02: Garbage Pit near Baseball Diamond

Sanitary practices, both at the household level and at the community level were another major point of interest. A high point of the investigation was that all respondents utilize the garbage pickup service, which runs twice a week (Monday and Thursday). Prior to pickup most respondents either used a waste bin or a woven sack to store their garbage. On a community level, however, garbage could be found collected in certain areas, particularly just outside the bounds of the community. In some cases, bundles of garbage were found in local waterways and streams and in some fields. It is unknown who is disposing of the garbage in these areas, however this is an example of how waste disposal services still need to make more progress.

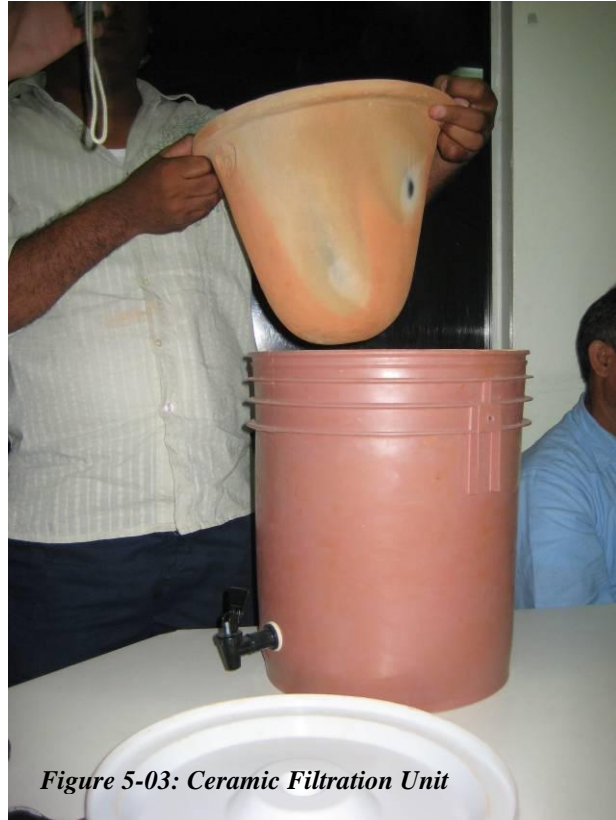
Figure 5-03: Ceramic Filtration Unit

In order to address the two issues of water quantity and quality in medium and long terms, there are some further investigations that should be performed. One perception that was very common in Los Toros was that filtration was sufficient to make the aqueduct water drinkable. For this reason, an ideal solution would be to find a physical filtration method that cleans the water to an acceptable level without the need for much maintenance or additional additives and chemicals. To that end, EWB Marquette plans to purchase and test ceramic filters which use a technology recognized by a number of international aid organizations². The filters are comprised of a mixture of red clay and sawdust, and fired in a kiln to produce small pores in the material. These small pores are designed to allow clear water to pass through the filter and inhibit bacteria from passing through the filter.

While on the assessment trip, PLAN International displayed one of these filters and made a recommendation for an in country vendor of the ceramic filters. PLAN International purchased the filter for \$450 pesos. The string-carbon filters used currently cost approximately \$350 pesos, however the effectiveness is dependent on the adherence to recommended treatment protocol. In addition, the purported lifecycle of a ceramic filter is around 2-3 times as long as the string carbon filters (2-3 years). If laboratory testing indicates that the ceramic filters are at least as good at removing harmful contaminants from the water sources as the string-carbon filters with chlorination, then the next step would be to introduce the ceramic filters on a trial basis to gauge in-field effectiveness and acceptance by the community.

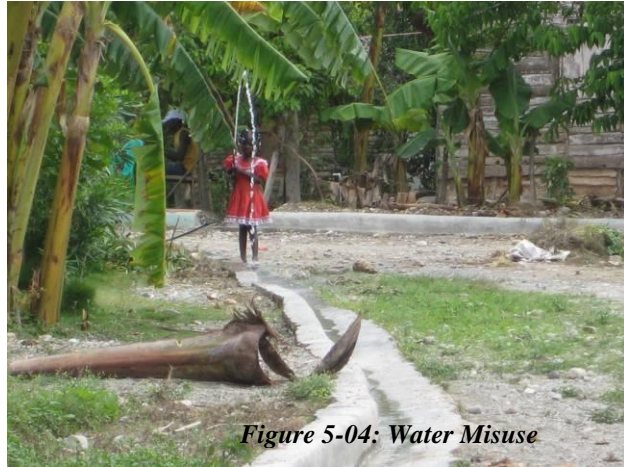
Figure 5-04: Water Misuse

The first step in improving the available water is to address homes that have open water hoses and piping. As shown at right, there were some homes where the water ran freely without being use for any specific purpose. In these cases, additional valves that can be purchased locally should be installed in order to minimize wasted water. A reporting system such as a community bulletin board for the plumber may be helpful in being able to more quickly react to these failures in the system, due to the size of the population that he has to serve.
