Pictures From Los Toros Water Infrastructure and Project

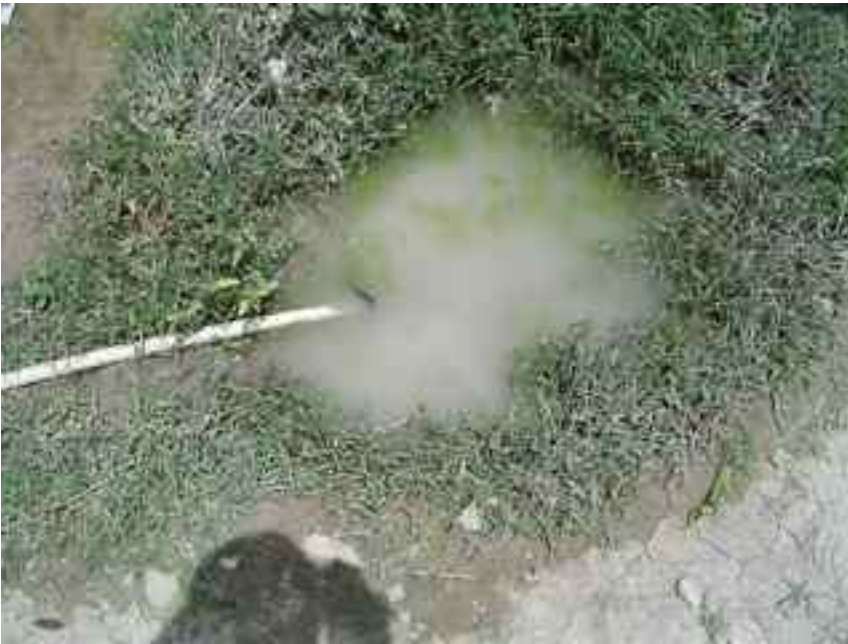
Example of a common water tap in Los Toros. This would typically serve a small grouping of homes. Oftentimes the taps (*llaves*) do not shut off properly and water is wasted.

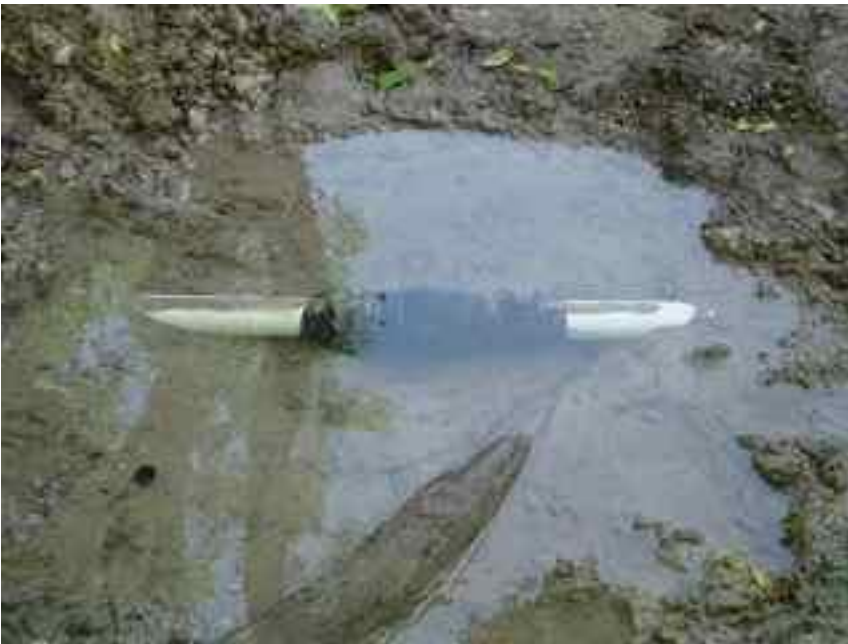
This $\frac{1}{2}$ " to $\frac{3}{4}$ " pipe serves a tap similar to the one above. When the connections break underground, pools of contaminated water form around the break. There are many breaks like this in Los Toros.

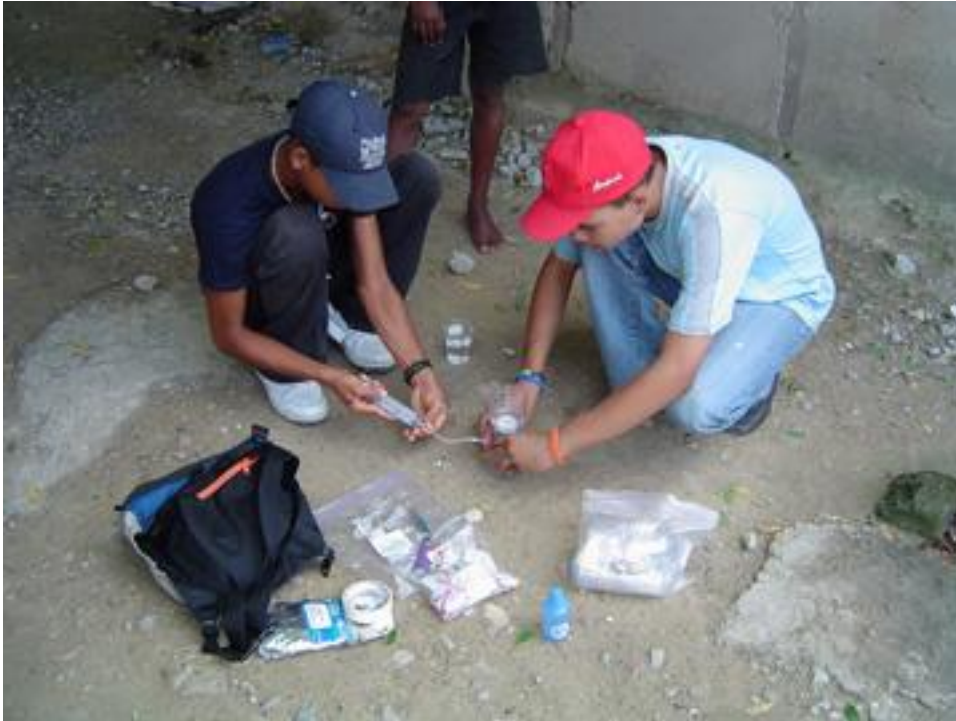
Testing water from a two-stage bucket filter for fecal coliform in June 2006.
